Analyst[®] TF 1.8 Software

Release Notes

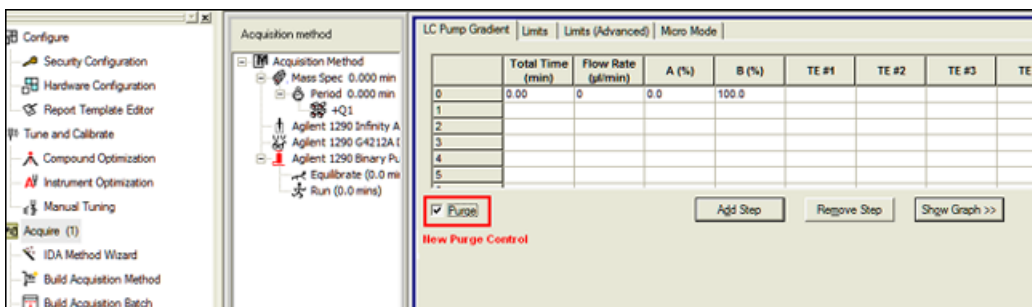
Figure 4-1 Purge Option in the Acquisition Method Editor

When the Purge option is activated, the Agilent 1290 Binary Pump opens the purge valve, allowing system purging.

To create a purging method, use only the Total Time, Flow Rate, and A/B(%) fields. Values entered into the Limits, Limits (Advanced), and Micro Mode tabs are ignored.

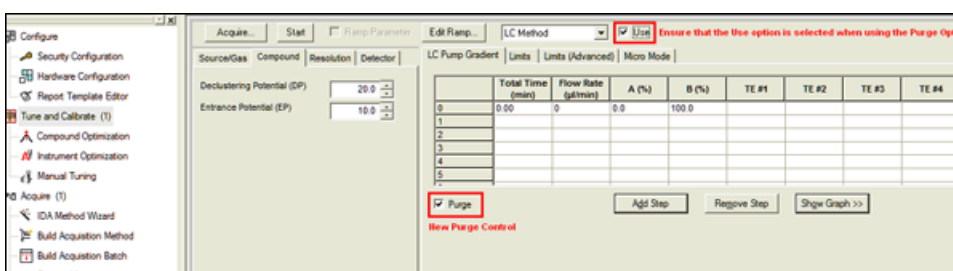
Figure 4-2 Purge Option in Manual Tuning

Users can either use Manual Tuning to purge or prime their system, or they can create an acquisition method to be used exclusively for purging. This method can be submitted via the Acquisition Batch Editor in the same manner as acquisition methods. In this scenario, the mass spectrometer acquires data to the specified wiff file.

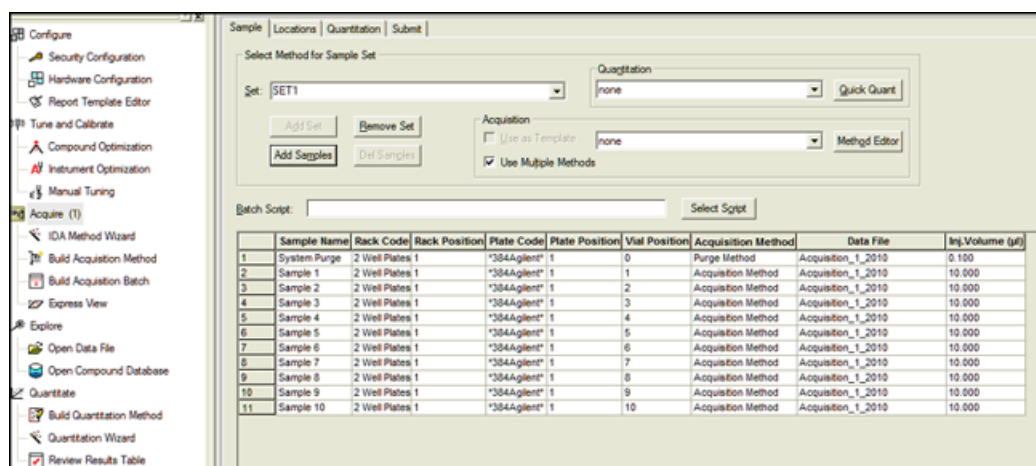
Figure 4-3 Example Acquisition Batch with a Purge Method Before Acquisition
