# SelexION<sup>®</sup> or SelexION<sup>®</sup>+ Technology

## Differential Mobility Separation Device

### Troubleshooting for Customers

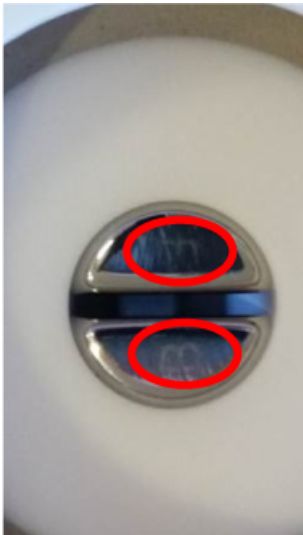
Possible Cause	Diagnosis	Corrective Action
<p>The electrodes are misaligned.</p>	<ol style="list-style-type: none"> <li data-bbox="482 319 966 462">1. (SelexION<sup>®+</sup> technology) Make sure that the "B" marking is visible on the side of the ion mobility cell that faces into the mass spectrometer.</li> <li data-bbox="482 491 966 558"> <p><b>Figure 1-1 "B" Marking on the Electrodes</b></p>

</li> <li data-bbox="482 1150 966 1444">2. (SelexION<sup>®</sup> technology) Make sure that the end of the electrode that extends furthest from the screw is closest to the mass spectrometer. The electrode must be flush with the surface of the ion mobility cell.</li> <li data-bbox="482 1377 966 1444">3. Verify horizontal alignment with the spacer tool.</li> </ol>	<p>Reassemble and align the electrodes with the spacer tool.</p>
